March 18, 2011

Apex Engineering, Inc.
27 West Market Street
Newport, Delaware 19804

**SUBJECT: WETLANDS INVESTIGATION OF 20 MONTCHANIN ROAD
NEW CASTLE COUNTY TAX PARCEL 07-030.10-015**

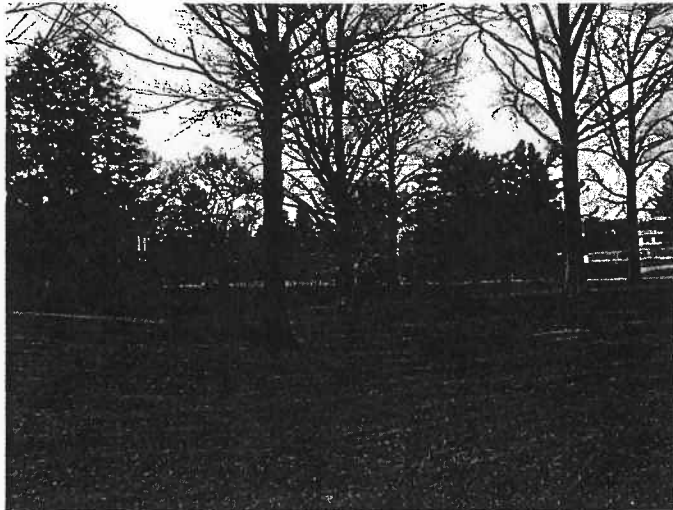
View looking southwest across maintained lawn area in the southwestern corner of the property.

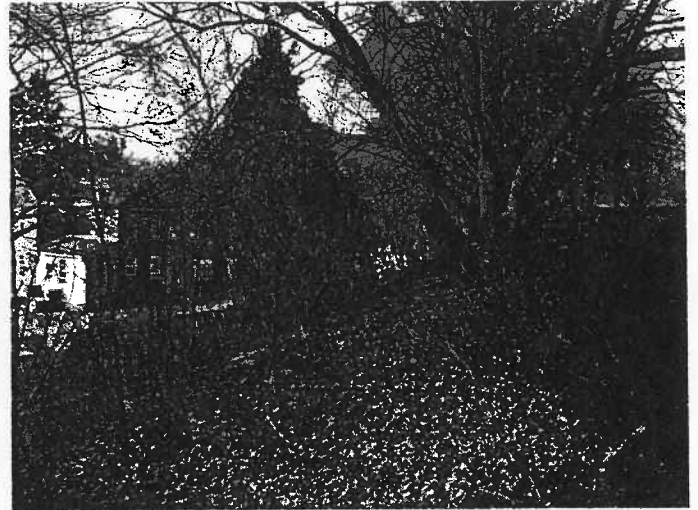
Steep slope adjacent to parking lot in the southern portion of the property.

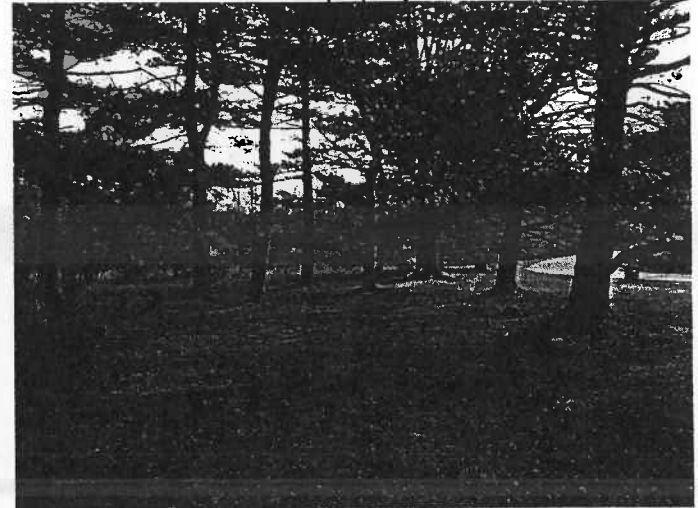
White Pines located along the north-central property boundary.

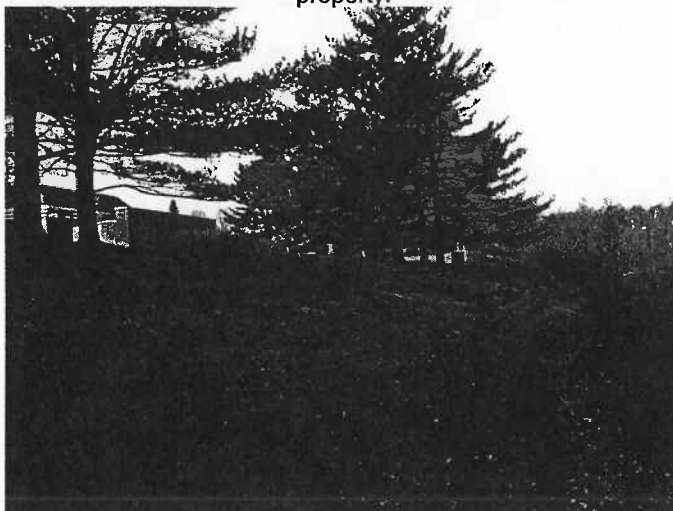
View looking west along the northern property boundary from the northwestern corner of the site.

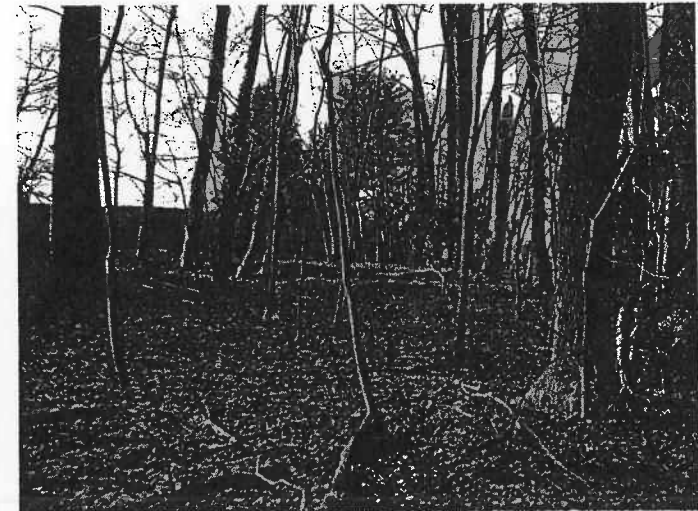
Wooded upland in the northeastern corner of the property.

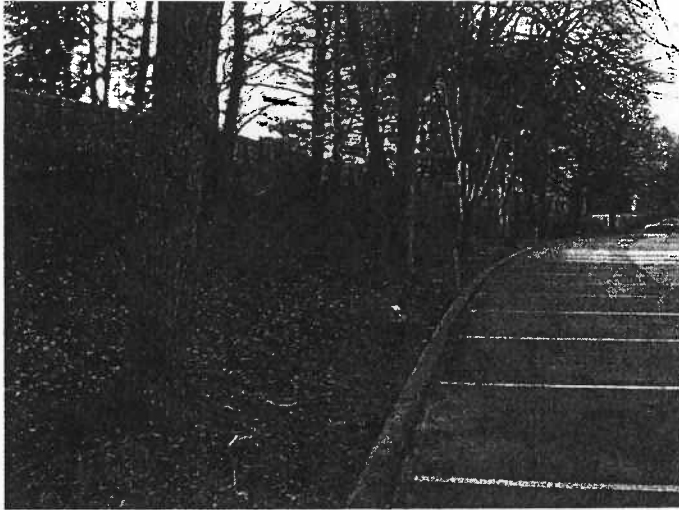
Wooded upland along the eastern property boundary.

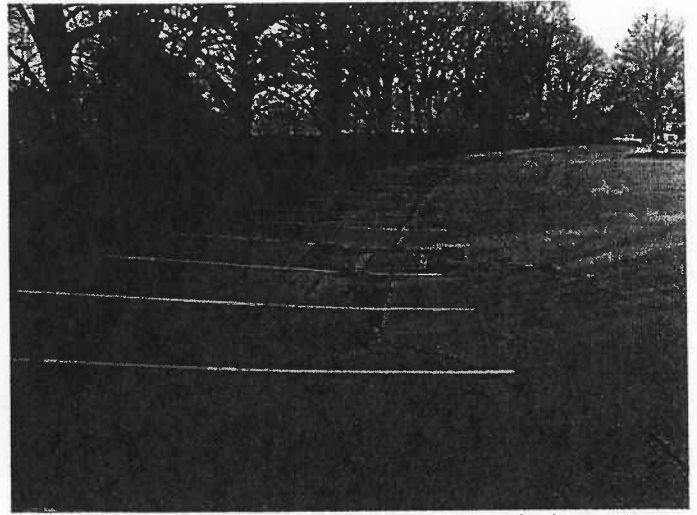
Storm-drain located within paved parking lot in the eastern portion of the property.

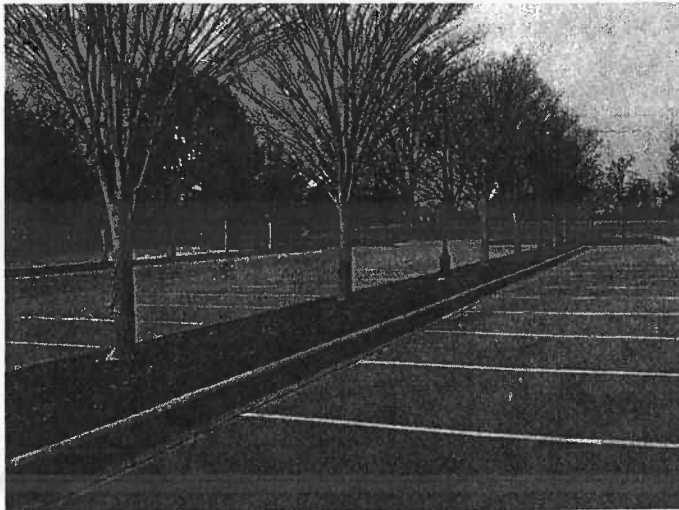
Ornamental trees located within island of parking lot in the southwestern portion of the property.

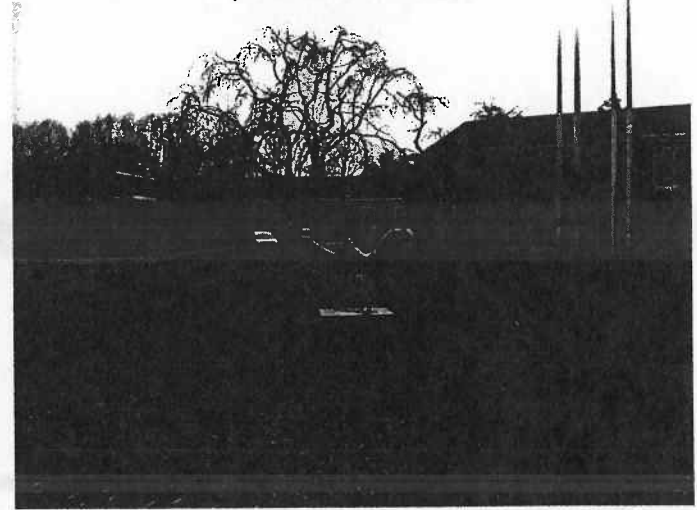
Looking east at landscape island in the front of the building.
