March 18, 2011

Apex Engineering, Inc.
27 West Market Street
Newport, Delaware 19804

**SUBJECT: WETLANDS INVESTIGATION OF 20 MONTCHANIN ROAD
NEW CASTLE COUNTY TAX PARCEL 07-030.10-015**

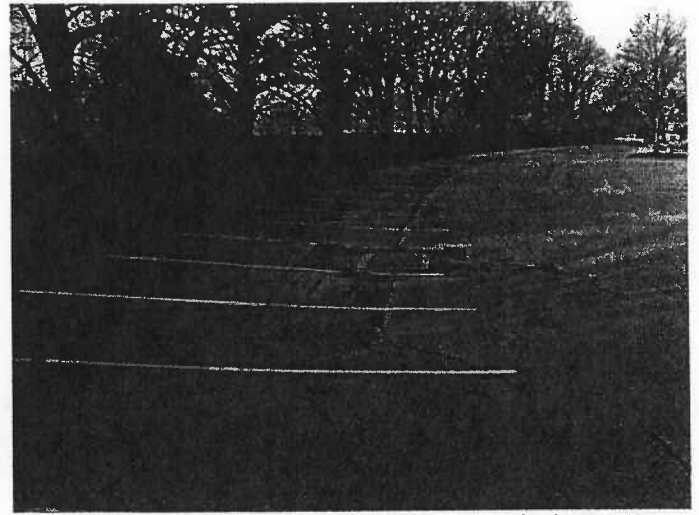
Surface water runoff from the subject property drains into existing storm drains within the maintained lawn areas and paved parking lots. This water is likely conveyed off-site to Brandywine River. No hydrology indicators were observed, nor indicators that would suggest seasonal high water tables (within 18" of the surface) within the subject property.

Storm-drain located within paved parking lot in the eastern portion of the property.

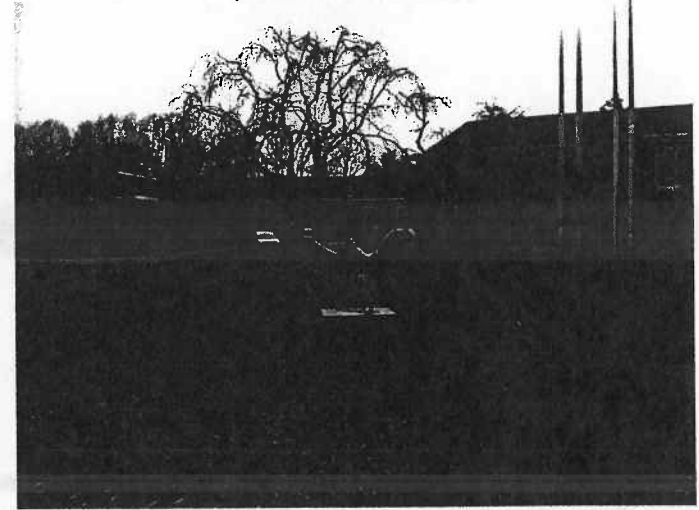
Looking east at landscape island in the front of the building.
